Spartan-3A Evaluation Kit Errata

August 4, 2009

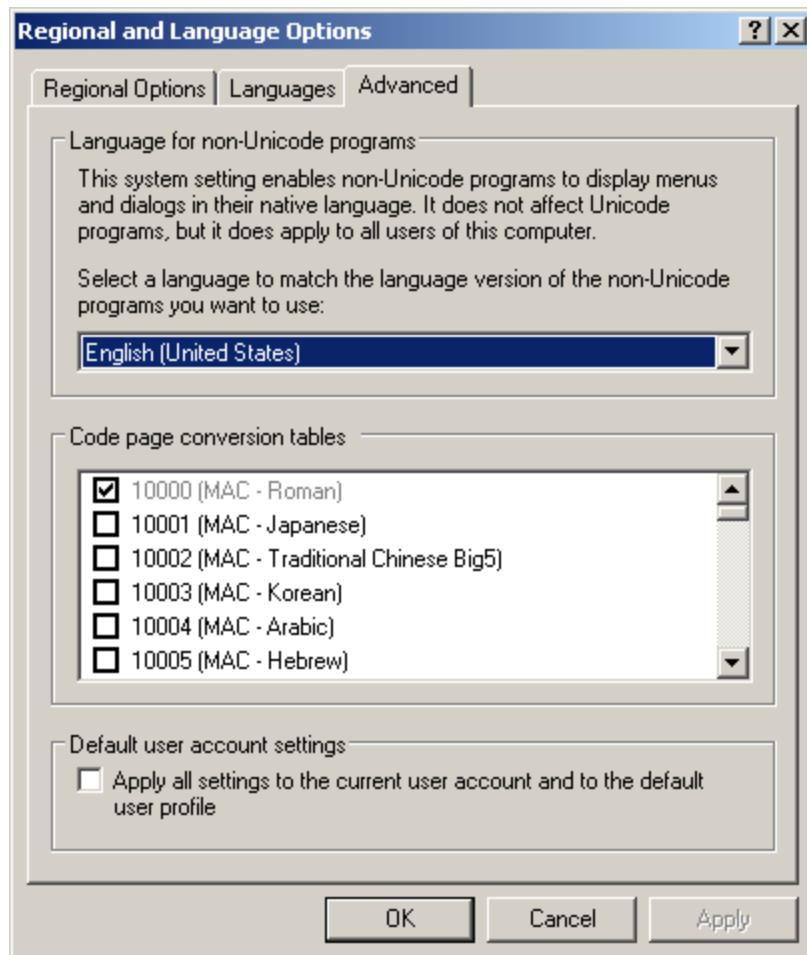
Figure 2 – Setting the Language for non-Unicode programs in Windows

AvProg was designed using Microsoft Visual Basic v6.0. This version of VB creates applications that internally are non-Unicode. Windows XP and Windows Vista are both full Unicode operating systems. When AvProg runs in Windows, the non-Unicode characters are translated to Unicode characters as a function of the O/S. For English language computers, this is not an issue as the Unicode and non-Unicode characters are the same. However, for non-English computers, the non-Unicode characters are not the same as some Unicode characters.

This is an issue since AvProg relies on specific character strings to be sent to the Spartan-3A Evaluation board as commands. When the non-Unicode characters get translated to Unicode, the strings are corrupted, which in turn corrupts the commands and communication between computer and board.

To correct this problem, you must change the “Language for non-Unicode programs” on the host system to English. Follow the instructions below to do this on a Windows XP system:

- a. Launch the **Control Panel** from the Start Menu.
- b. Double-Click **Regional and Language Options**.
- c. Select the **Advanced** tab.
- d. Select **English** in the list box, as shown below.
- e. Click the **OK** button.
